Report No : GIS-20070581

INSPECTION REPORT

Table with 2 columns: Field Name and Value. Fields include Applicant, Attn, Supplier, Factory, Factory Address, P/O No., P/O Quantity, Model/Art/Style, Product Description, Inspection type, Inspection method, and Inspection date. Includes an image of a black air fryer.

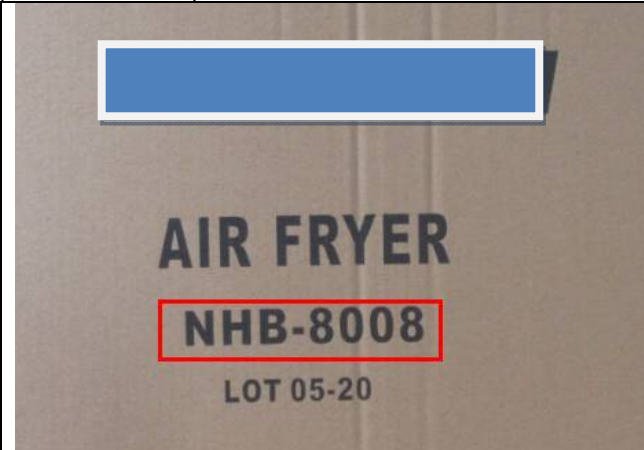
1	No CE marking on export carton during inspection	
2	Actual found item NHB8008 shown on shipping carton&giftbox and instruction manual, but HB-8008 shown on rating label, please see below photo.

Shown on shipping carton	Shown on instruction manual

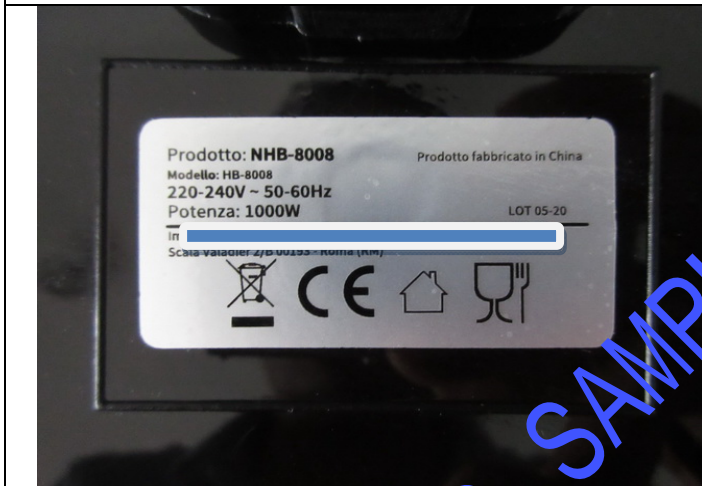
21 Rating label

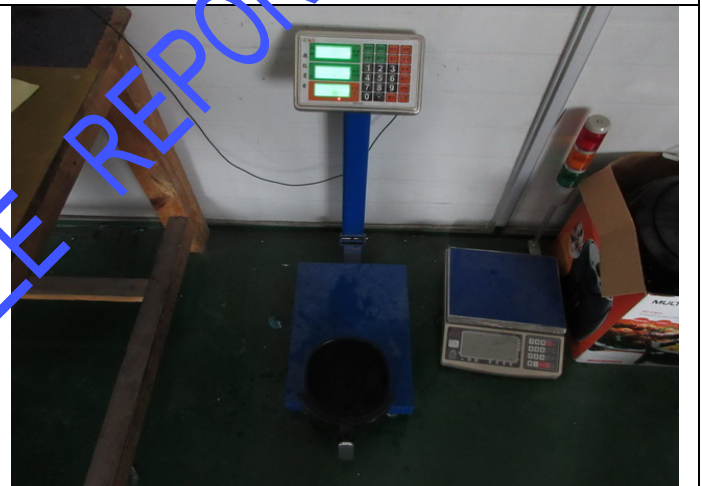
Shown on giftbox	Shown on rating label
3	Actual found steel basket capacity is 2.2L instead of 2.4L (Client's checklist) during inspection.

46 Capacity check (1)

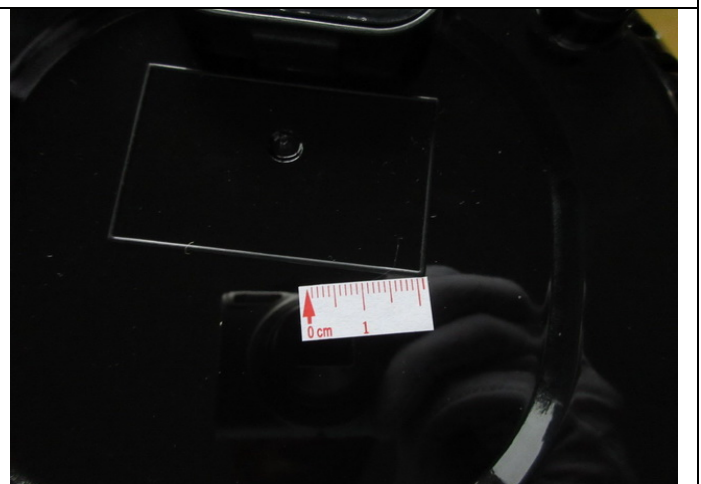
Inspection Standard: ANSI/ASQC Z1.4		Defect classification	Cr	Ma	Mi
Sampling Plan:	Single, Normal	AQL	0	1.5	4.0
Inspection Level:	<input checked="" type="checkbox"/> G-II	Sample size	200	200	200
The defects which were found during inspection were listed as below:					
Item:NHB-8008					
1	Missing rating label		1	--	--
2	Crack mark on side of the light cover		--	1	--
3	Gap mark between two housing (2.5mm)		--	--	1
4	Slightly poor assembly of the housing		--	--	5
5	Slightly chipped mark on housing		--	--	1
6	Scratch mark on housing		--	--	7
7	Removable dirty mark on housing		--	--	6
8	Poor silkscreen printing		--	--	1
9	Paint peeled off on the handle		--	--	1
Total Found:			1	1	22
Allowed:			0	7	14
Result			Fail

72 Defect-Missing rating label-Critical

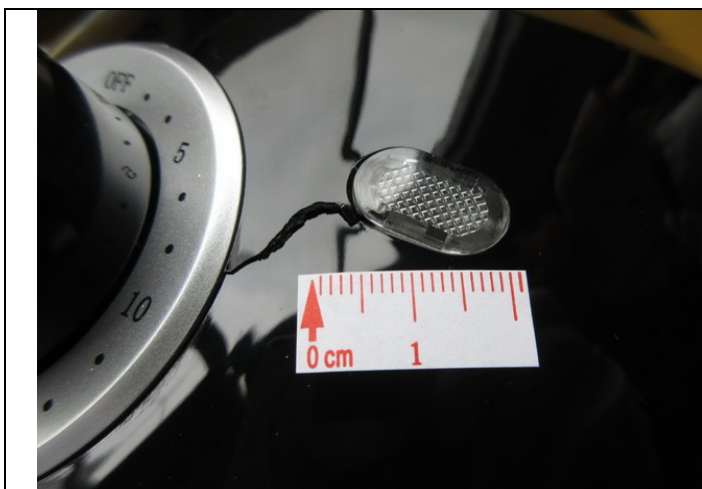
73 Defect-Crack mark on side of the light cover-Major

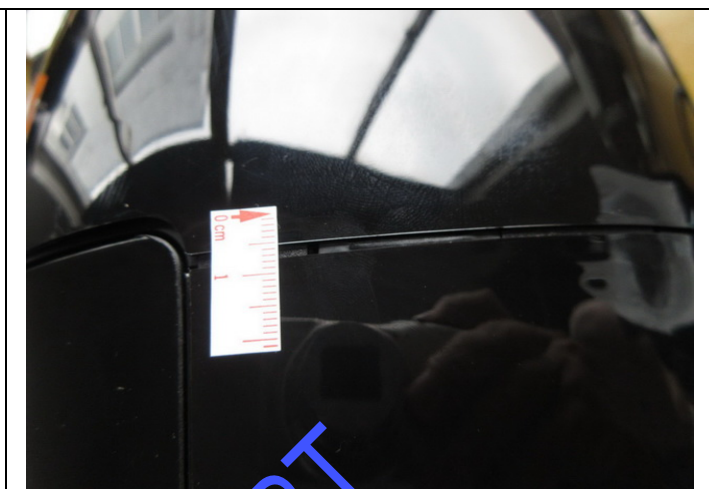
74 Defect-Gap mark between two housing (2.5mm)-Minor

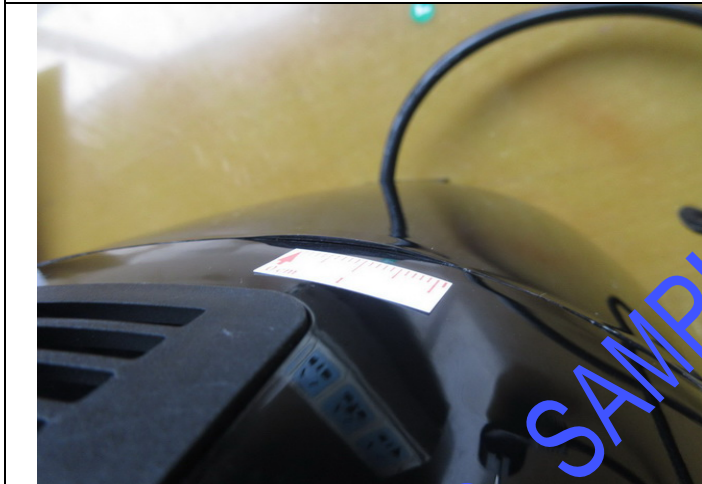
75 Defect-Slightly poor assembly of the housing (1) -Minor

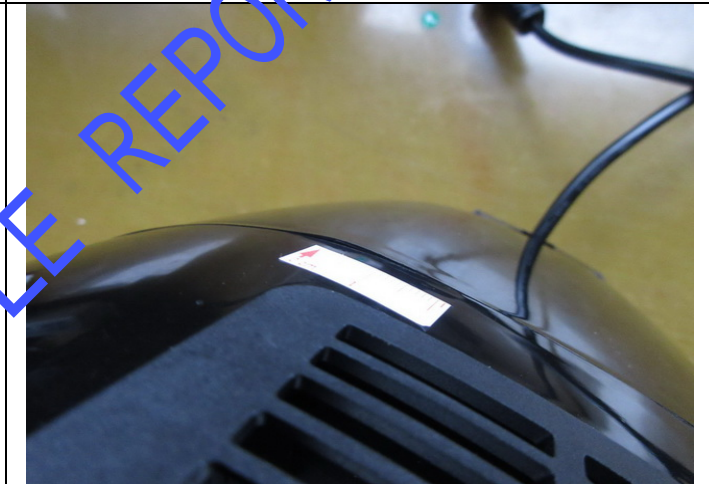
76 Defect-Slightly poor assembly of the housing (2) -Minor

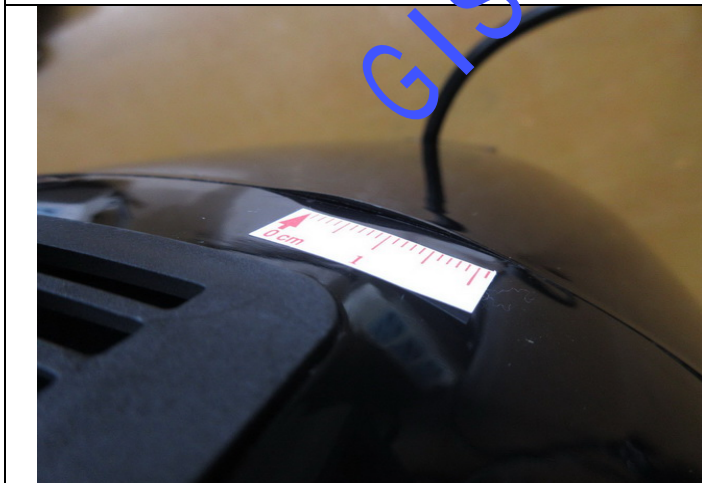
77 Defect-Slightly poor assembly of the housing (3) -Minor

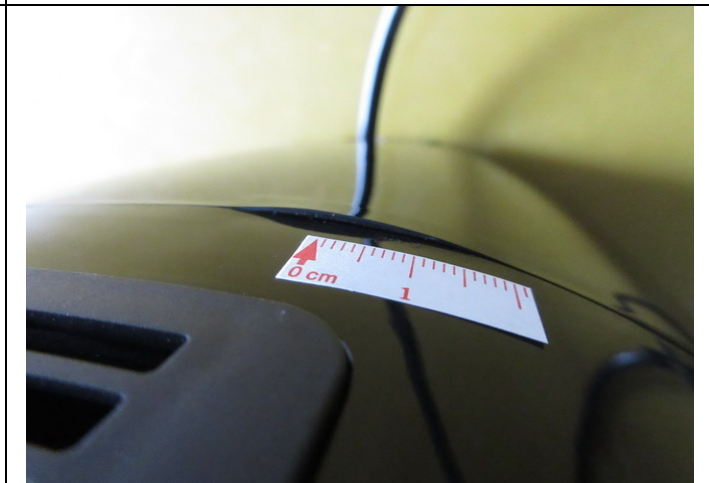
78 Defect-Slightly poor assembly of the housing (4) -Minor

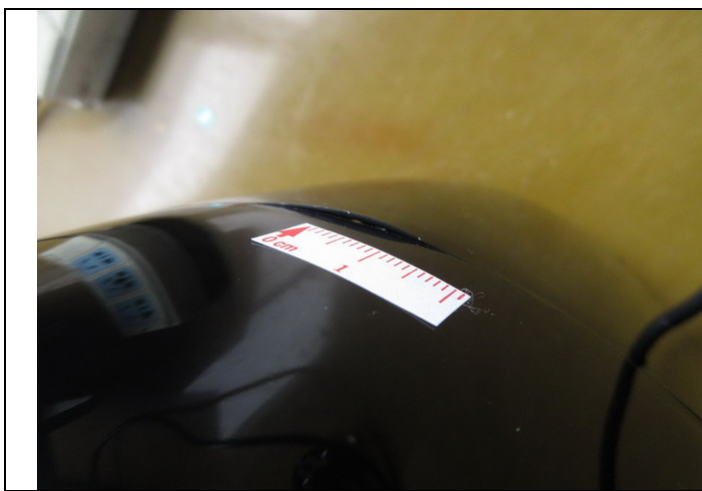
79 Defect-Slightly poor assembly of the housing (5) -Minor

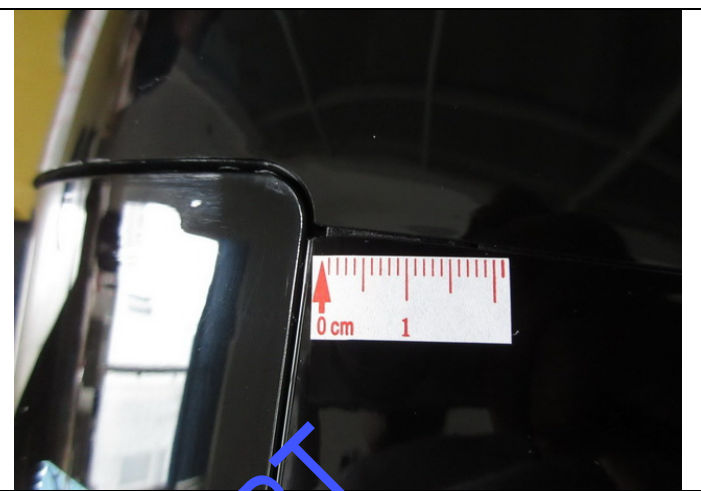
80 Defect-Slightly chipped mark on housing-Minor

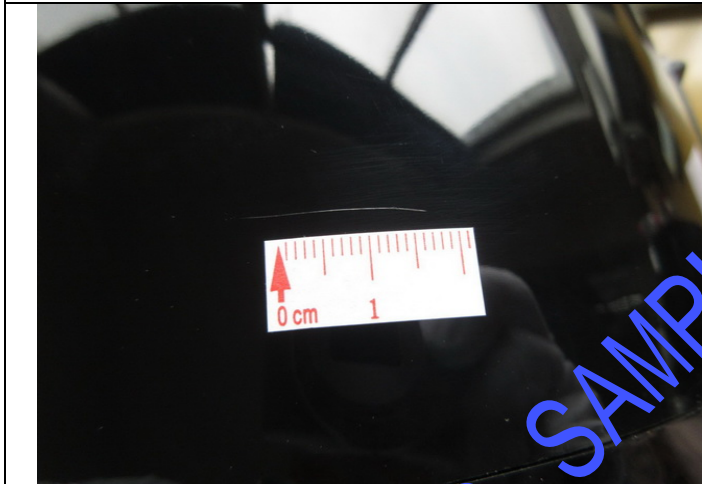
81 Defect-Scratch mark on housing (1) -Minor

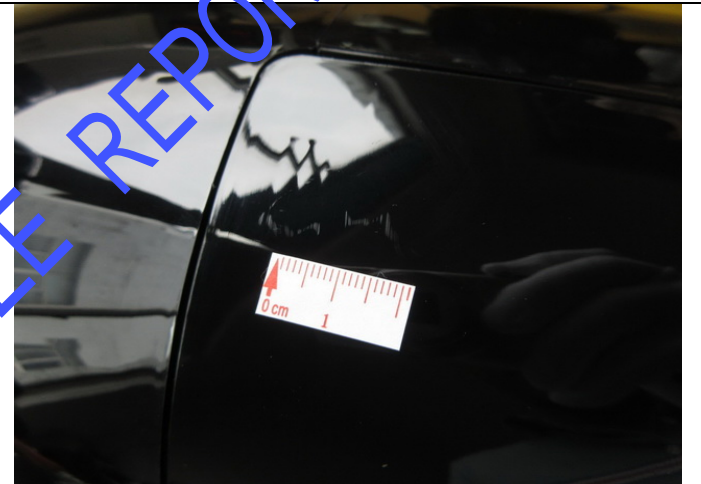
82 Defect-Scratch mark on housing (2) -Minor

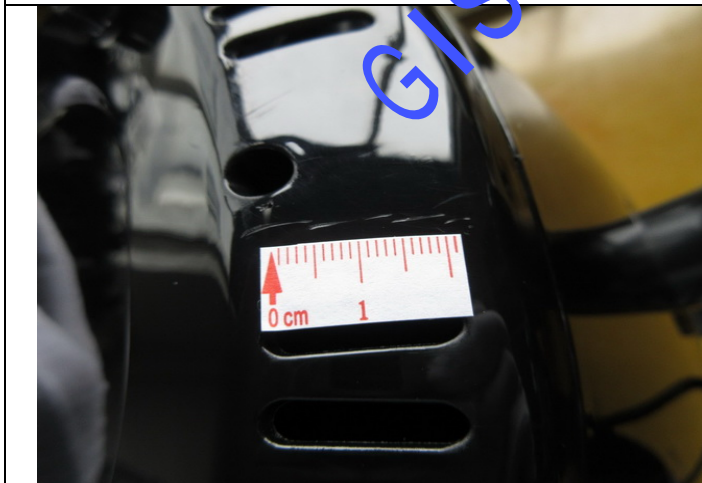
83 Defect-Scratch mark on housing (3) -Minor

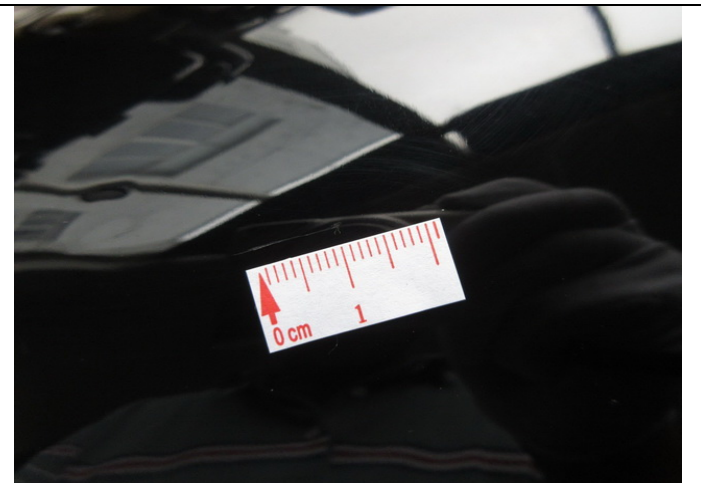
84 Defect-Scratch mark on housing (4) -Minor

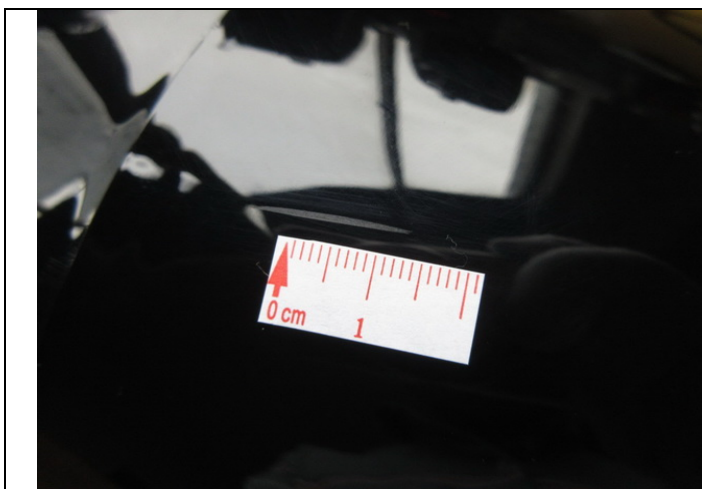
85 Defect-Scratch mark on housing (5) -Minor

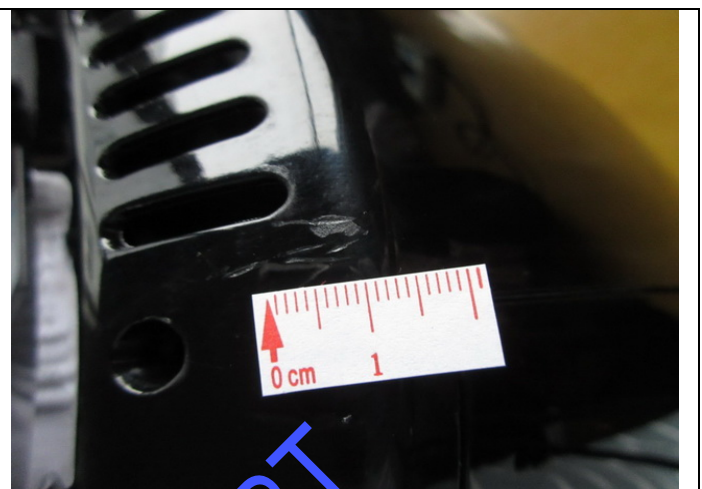
86 Defect-Scratch mark on housing (6) -Minor

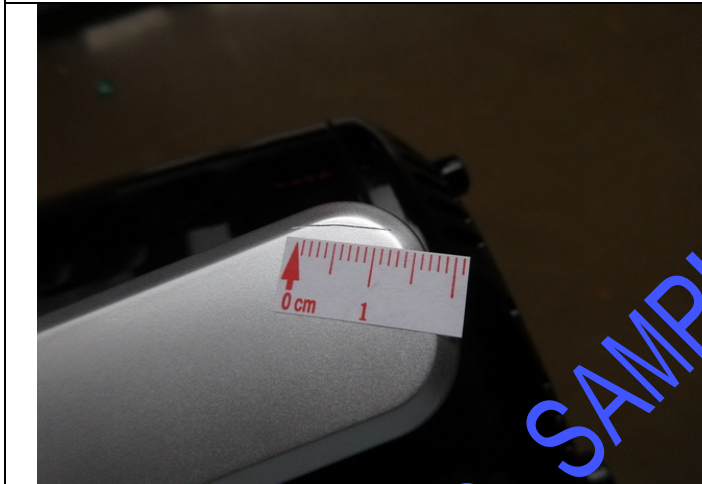
87 Defect-Scratch mark on housing (7) -Minor

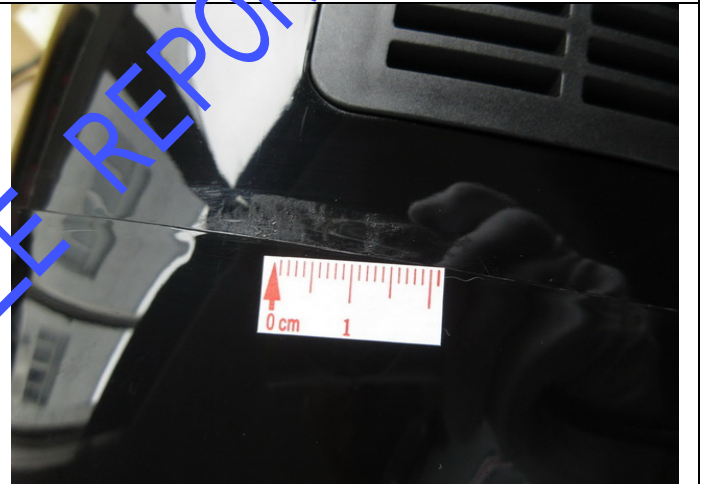
88 Defect-Removable dirty mark non housing (1) -Minor

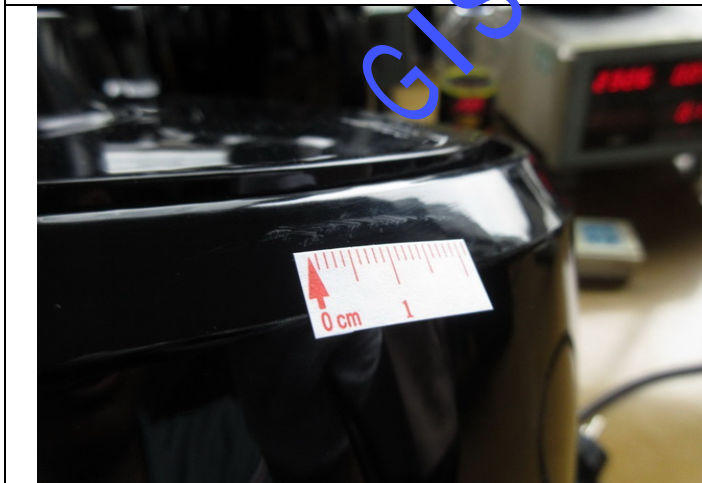
89 Defect-Removable dirty mark non housing (2) -Minor

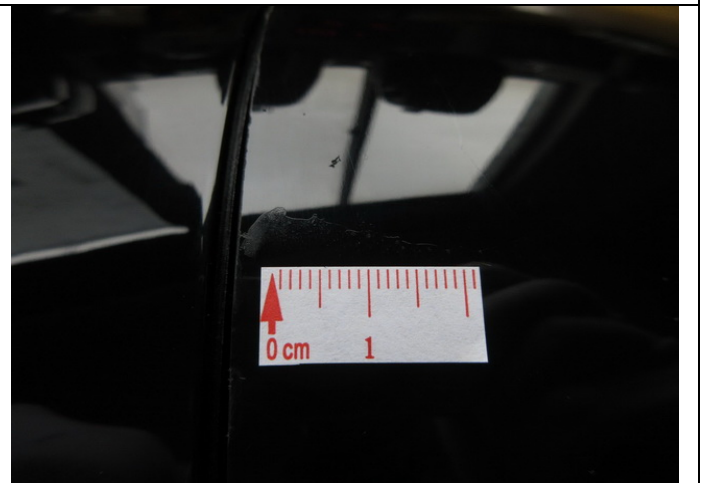
90 Defect-Removable dirty mark non housing (3) -Minor

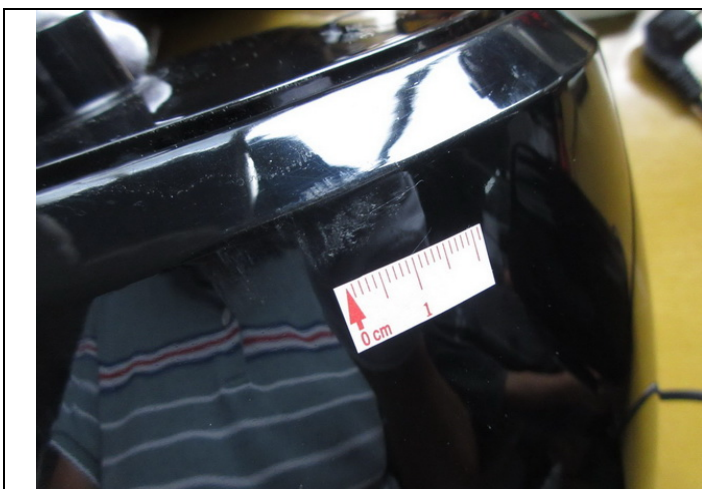
91 Defect-Removable dirty mark non housing (4) -Minor

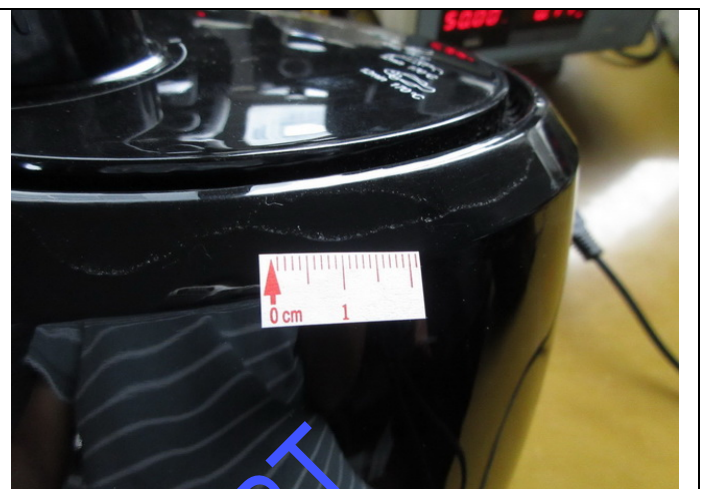
92 Defect-Removable dirty mark non housing (5) -Minor

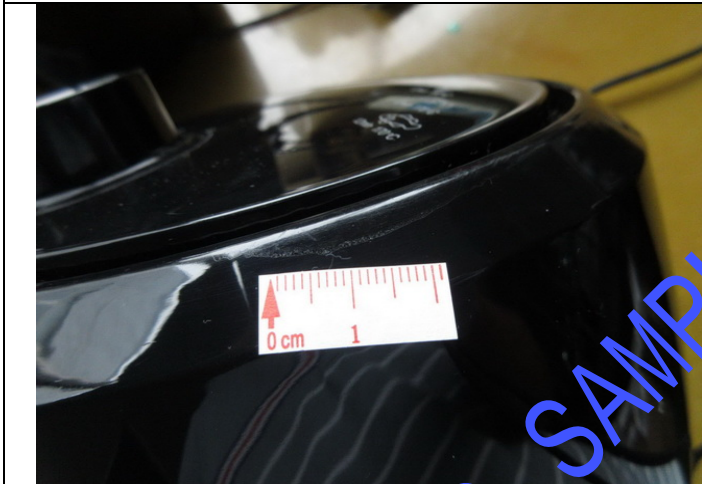
93 Defect-Removable dirty mark non housing (6) -Minor

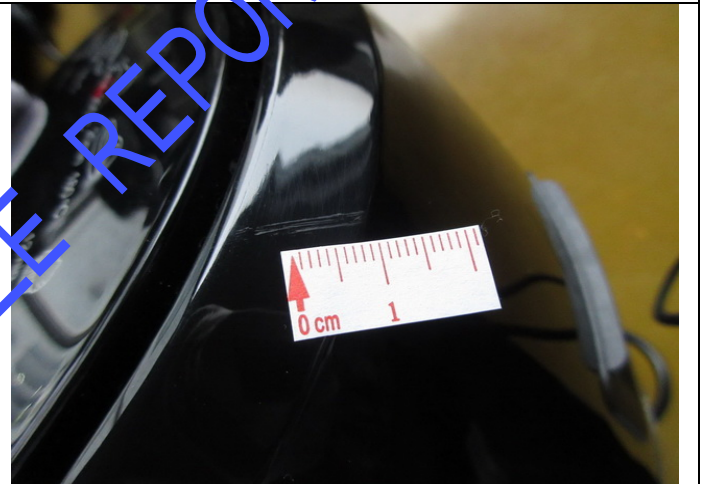
94 Defect-Removable dirty mark non housing (7) -Minor

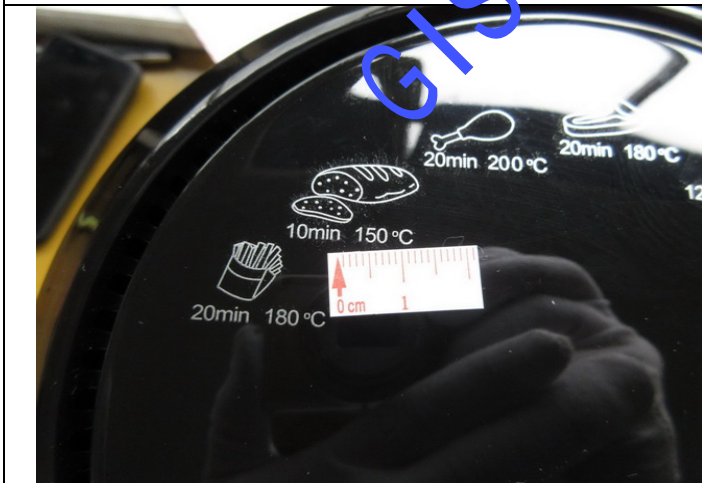
95 Defect-Poor printing of the silkscreen-Minor

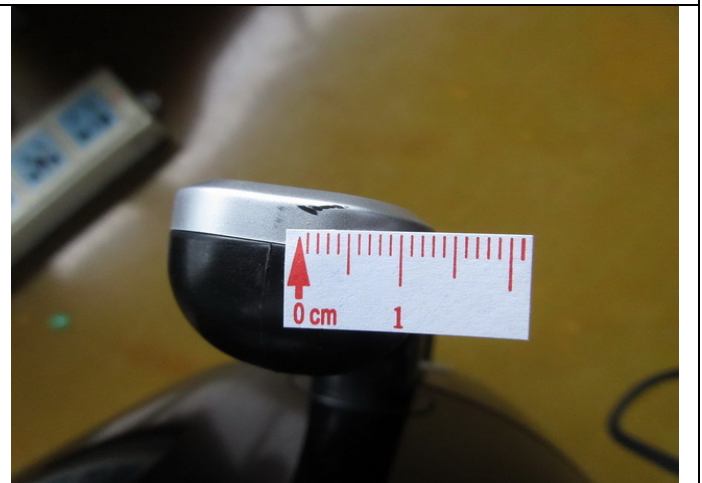
96 Defect-Paint peel off the handle-Minor
