Report No : GIS-17050117

INSPECTION REPORT

Applicant	:	-	
Attn	:	-	
Supplier	:	-	
Factory	:	-	
Factory Address	:	-	
P/O No.	:	W1B2051	
P/O Quantity	:	300pcs	
Model/Art/Style	:	NVR-4441 CV-235 (KS-235L White)	
Product Description	:	Fridge	
Inspection type	:	Pre-shipment Inspection	
Inspection method	:	<input checked="" type="checkbox"/> GWI-IE / <input checked="" type="checkbox"/> SWI-0302/ <input checked="" type="checkbox"/> CKL-IE-0602	
Inspection date	:	20XX-XX-XX

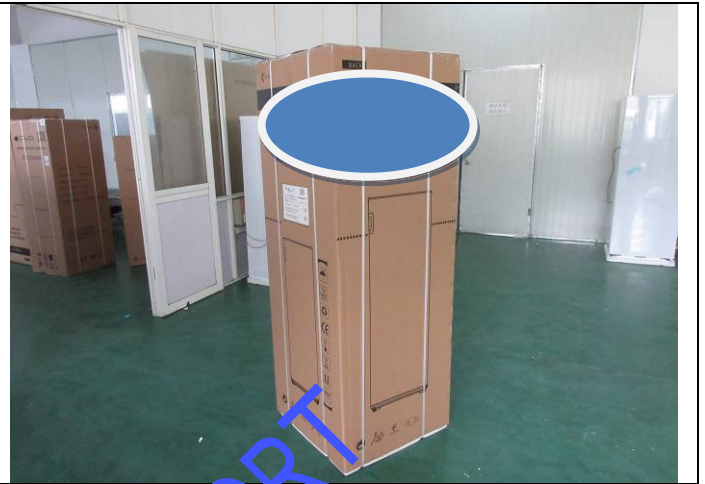
2 export carton

Please refer to photos.

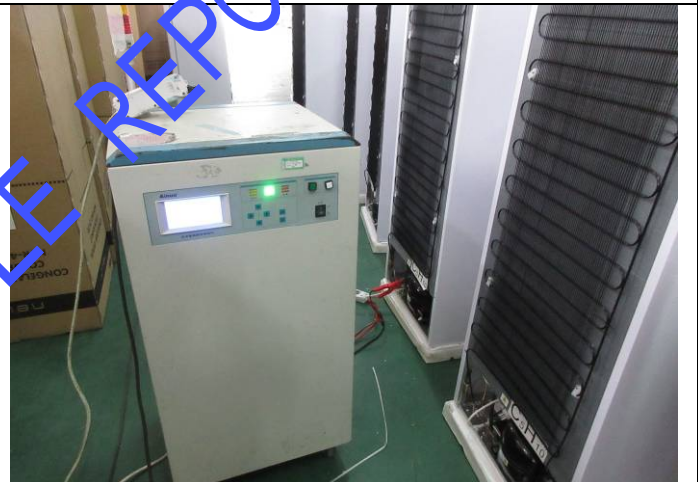
33 Hi-pot&Earth&Insulation test&Leakage current test (1)

-	Check points	Criteria	Sample size	Comment											
1	Hi voltage test	1500 Vac, 2s, 5mA	(50Samples):	No Breakdown.											
2	Earth resistance check	(25amp, < 0.1Ω)	(50Samples):	Conformed.											
3	Basic function check		(50Samples):	Conformed.											
4	Transportation Drop Test		(1Carton):	Not Conformed, refer to remark 1											
5	Power on check	4 hours at 230V 50Hz	(2Samples):	Conformed.											
6	Internal check for workmanship		(2Samples):	Conformed.											
7	Stability check	15 degree	(2Samples):	Conformed.											
8	Rub and tape test	With water for 15s 3M,810 tape	(5Samples):	Conformed.											
9	Strain relief check	100N 25 times	(2Samples):	Conformed.											
10	Compressor protection check		(2Samples):	Conformed.											
11	Noise check		(2Samples):	Not Conformed. Refer to remark 4											
12	Leak tightness check		(2Samples):	Conformed.											
13	Low voltage starting check	35% of rating voltage	(50Samples):	Conformed.

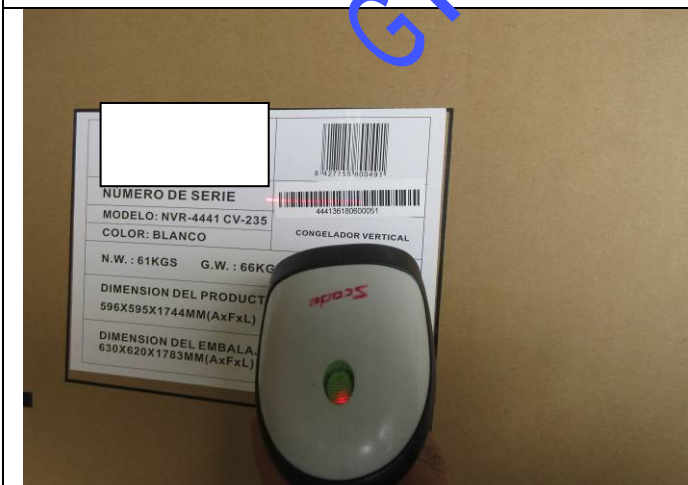
34 barcode scan (1)

Item	Setting	Reading (lower power)	Reading (high power)												
NVR-4441	Med	68.8W	78.3W												
	Max	59.5W	60.5W												
22	Barcode readability check		(5Samples):	Conformed.											
<table border="1"> <thead> <tr> <th>Item No.</th> <th>Barcode No.</th> <th>Location</th> <th>Barcode No.</th> <th>Location</th> </tr> </thead> <tbody> <tr> <td>NVR-4441</td> <td>8427155800491</td> <td>A</td> <td></td> <td></td> </tr> </tbody> </table> <p>*Location code: A-Export Carton; B-Gift Box; C-Blister Card; D-Unit; E-Hangtag; F-Inner White Box; G-Other</p>					Item No.	Barcode No.	Location	Barcode No.	Location	NVR-4441	8427155800491	A

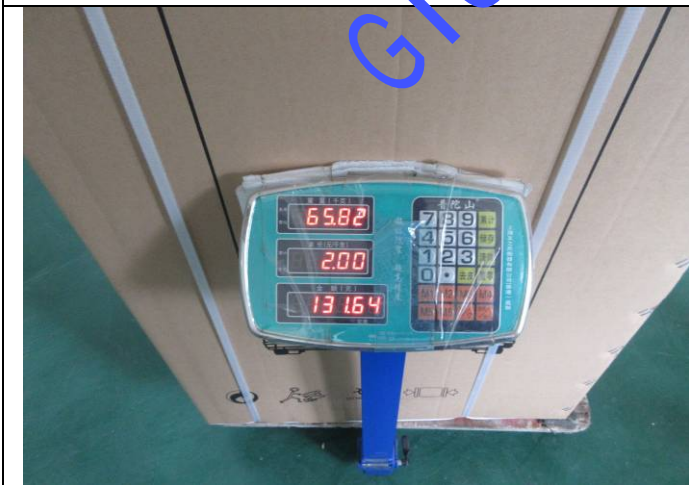
40 weight check (1)
