Report No : GIS-20070581

INSPECTION REPORT

Table with 2 columns: Field Name and Value. Fields include Applicant, Attn, Supplier, Factory, Factory Address, P/O No., P/O Quantity, Model/Art/Style, Product Description, Inspection type, Inspection method, and Inspection date. Includes an image of a black air fryer.

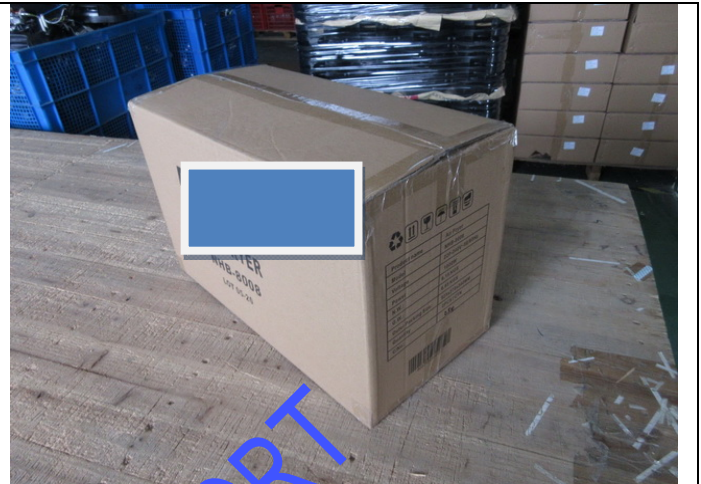
2 Export carton

1	No CE marking on export carton during inspection	
2	Actual found item NHB8008 shown on shipping carton&giftbox and instruction manual, but HB-8008 shown on rating label, please see below photo.

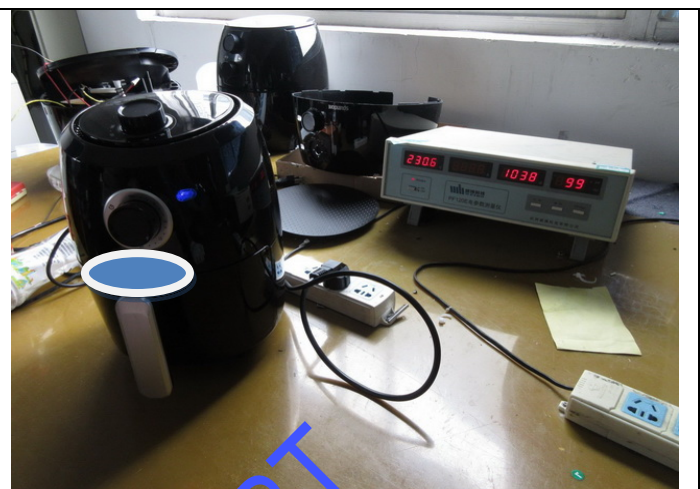
38 Power consumption check

13	Power consumption check	At 230V 50Hz	(200Samples):	Conformed.															
<table border="1"> <thead> <tr> <th>Setting</th> <th>Reading (range)</th> <th>Requirement</th> </tr> </thead> <tbody> <tr> <td>Max</td> <td>1010-1040W</td> <td>1000W</td> </tr> <tr> <td colspan="3">Data marked with '*' was/were found out of specification.</td> </tr> </tbody> </table>					Setting	Reading (range)	Requirement	Max	1010-1040W	1000W	Data marked with '*' was/were found out of specification.								
Setting	Reading (range)	Requirement																	
Max	1010-1040W	1000W																	
Data marked with '*' was/were found out of specification.																			
14	Barcode readability check		(5Samples):	Conformed.															
<table border="1"> <thead> <tr> <th>Item No.</th> <th>Barcode No.</th> <th>Location</th> <th>Barcode No.</th> <th>Location</th> </tr> </thead> <tbody> <tr> <td>NHB-8008</td> <td>8057158460172</td> <td></td> <td></td> <td></td> </tr> <tr> <td colspan="5">*Location code: A-Export Carton; B-Gift Box; C-Blister Card; D-Unit; E-Hangtag; F-Inner White Box; G-Other</td> </tr> </tbody> </table>					Item No.	Barcode No.	Location	Barcode No.	Location	NHB-8008	8057158460172				*Location code: A-Export Carton; B-Gift Box; C-Blister Card; D-Unit; E-Hangtag; F-Inner White Box; G-Other
